Manhole Inspection Summary

Manhole # S33KK1031MH

Insp Date: **2/28/07 3:26 PM**

Location Address: **4207 GREENWAY**

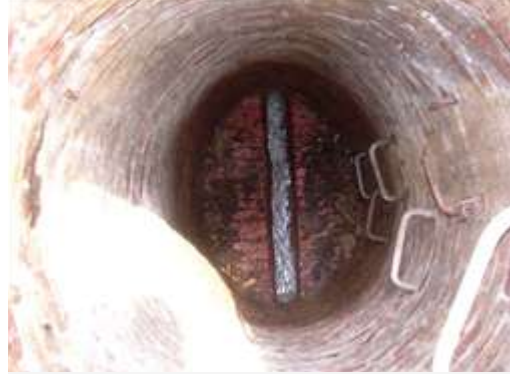
Top View

Corroded and missing steps. Evidence of surcharge - Bench debris.

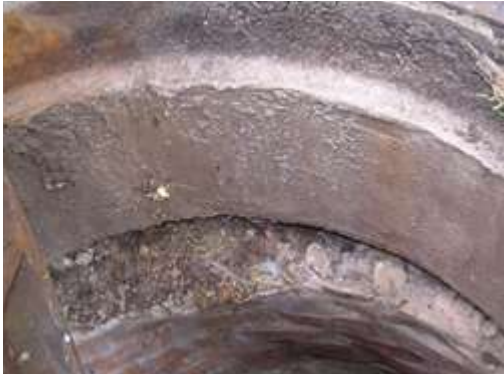
Defect

Frame leaks. Frame offset. Adjustment deterioration and infiltration.

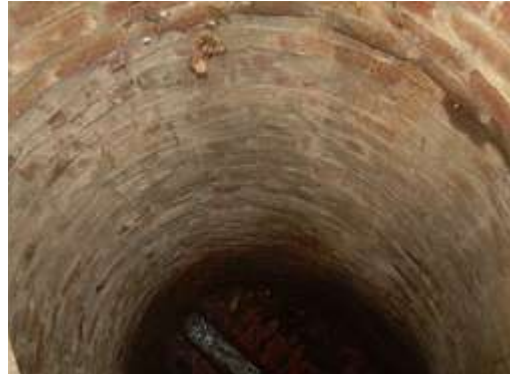
Defect

Adjustment and Barrel infiltration.

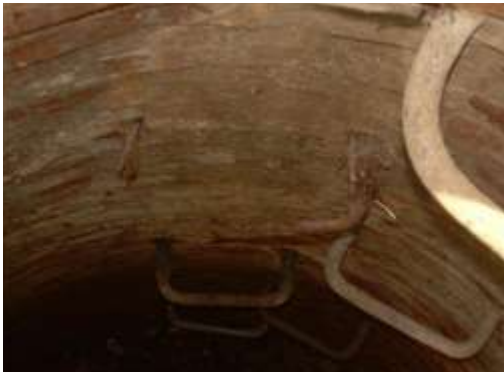
Defect

Barrel infiltration. Corroded and missing steps.

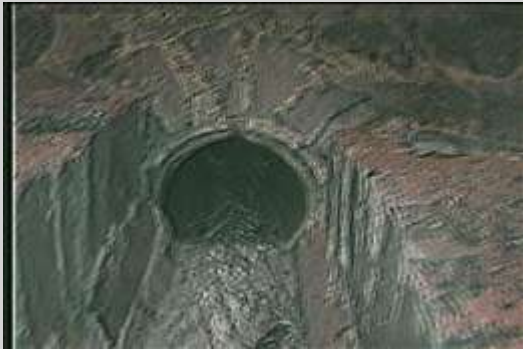
6 in. Circular Gravity Sewer Pipe Out @ 12 O'Clock

Infiltration: **Evidence** Pipe Seal Cond: **Cracked**

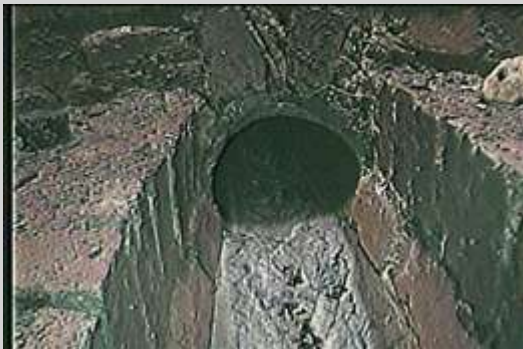
6 in. Circular Gravity Sewer Pipe In @ 6 O'Clock

Channel deterioration.

Infiltration: **Evidence** Pipe Seal Cond: **Unknown**
